## ***Re-boring a Polly*** – Mike Brown

### ***Some Boring Observations – Mike Brown***

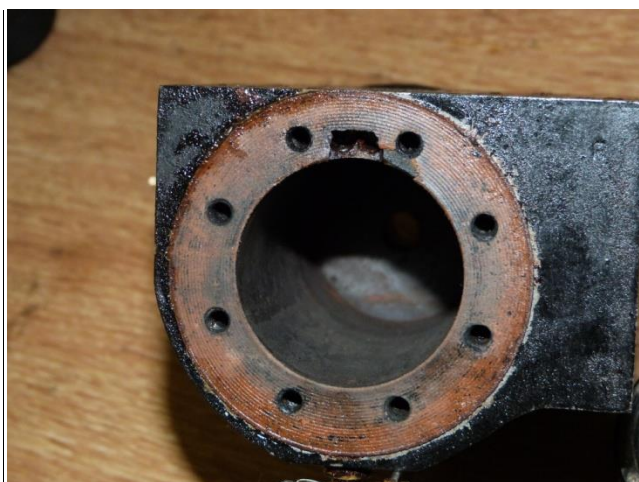
*Fig 1*

It was quite a few months before I could find workshop time to find the problem, but eventually the Polly went up on the turnover stand. When the end covers came off the cylinders a sorry sight awaited. There was a clear “tide mark” about 1/3 of the way up the cylinder walls (see fig 1). Below this there were clear signs of corrosion. So what had happened was that the cylinders had filled up with condensation and had then sat all winter rusting away. I should not exaggerate this, the depth of corrosion was probably no more than a few thou, but the surface was roughened. The Polly uses O rings. These have put up with considerable abuse when the lubricator was not working, but running over a rust roughened surface was too much for them

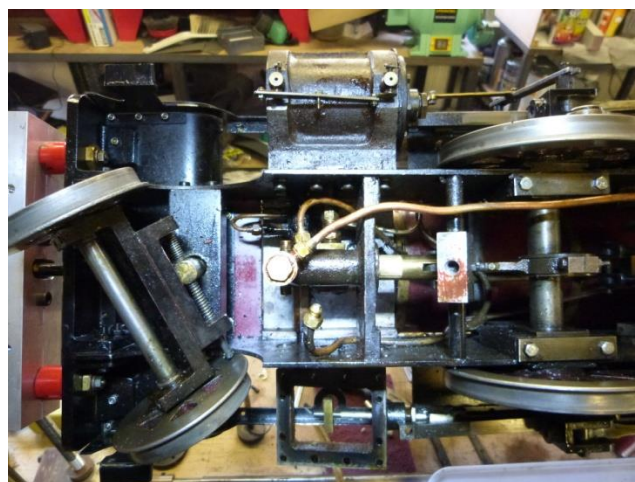
*Fig 2*

At first I thought that it was not going to be possible to remove the cylinders without taking off the boiler (see fig 2), but that prospect spurred me on and I eventually decided that it might be possible. Sure enough, after a titanic struggle with nuts and bolts near impossible to reach, I had the cylinders on the bench (see fig 3).

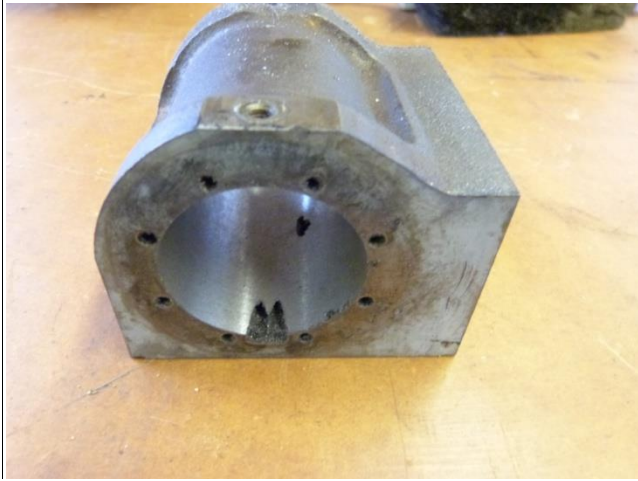
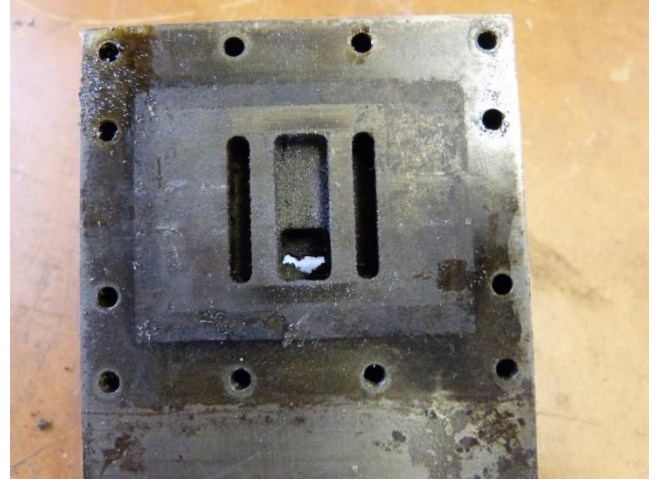
I was not sure how thick to make the bronze sleeve, but I settled on a 2mm wall thickness as providing enough mechanical strength to handle, while not being too thick and so getting too close to other things such as the end cap bolt holes. However at this thickness I was concerned that I might “breakthrough” into the transfer ports when boring. On reflection I decided that this would not matter as the sleeve itself would “heal” any holes and I pressed ahead with the boring. Sure enough there was a small breakthrough (see figs 7 and 8) but as hoped this did not cause any problems.

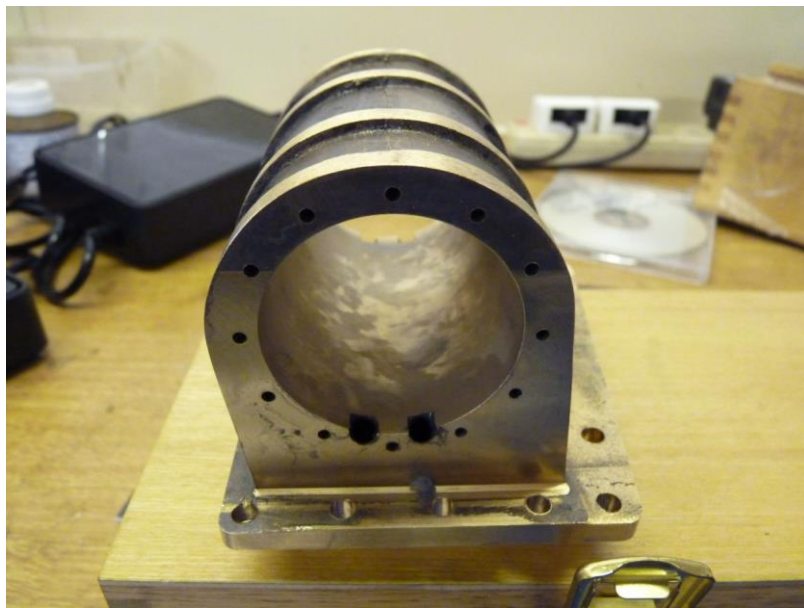
*Fig 3*

I then noticed a couple of things that may be of interest to others. As I monitored progress an unusual pattern started to appear in the bores (see fig 3 below).

The pattern had a random mottled effect and was more noticeable on the tops and bottoms of the cylinders, rather than on the sides. After a little head scratching I came up with the following explanation. As the cylinders are honed, the honing starts to take off the high spots first (leaving a dull fine matt finish). So why the mottling? I think that this is caused by the crystalline structure of the metal; it is a casting after all, so it is reasonable to expect crystals to form as the metal solidifies. Each crystal will be aligned differently and will have slightly different machining properties. Thus some crystals will be machined slightly deeper than others as the boring bar deflects, hence the mottling. So what about the pattern being more pronounced top and bottom of the cylinder. Easy explanation, if you look at how I was clamping the cylinder to machine it, you will see that the effect will be to squash the cylinder slightly. Thus when the clamp is removed the

cylinder will spring back causing the bore to become oval top to bottom; thus when honing, the sides of the cylinder will be smoothed out first.

I must say that I am surprised by these effects. First, I am amazed that the crystalline structure has enough effect on machining to be seen. Second, I am also amazed that the clamping force was enough to cause a significant effect on the shape of the cylinder (I did not do up the nuts that tight!) To get this in context though, after boring (and before honing) I set up the cylinders vertically in the mill to do some machining on the ends. I used my trusty centre finder to locate the thing. This has a dial gauge that is set to run true to the bore. When setting up, the deflection of the gauge was no more than 0.01mm (less than half a thou), so we are not talking about huge amounts here. Yet more lessons for the future.
