The “Brown Mk1” CNC Milling Machine – Mike Brown

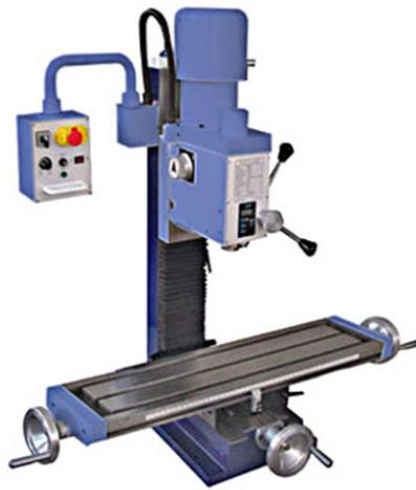
SPG 9525

This machine was similar in construction to those from a number of suppliers but it had a bigger machining envelope of X 550mm, Y 200mm, Z 400mm, and an R8 taper (handy as I already have a lot of R8 tooling). Also, the machine was available at a good price, so I bought it.

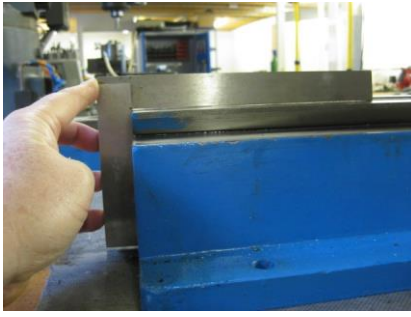
The accuracy of machining of the base

It was soon clear that the cause of the problem was primarily the machining of the base casting - not only was it out by a mile, the machined finish was also pretty poor. In addition, someone had attempted to “cure” the problem by having a go at the locating face at the bottom of the column with some sort of grinding tool. I now had a dilemma, torn between three options, return the machine and ask for my money back, have it replaced, or ask for it to be fixed. Well, it was just the size I wanted, I could not find an exact equivalent from another supplier, I knew that there were no others available until the next shipment from China (and I had already waited weeks for this one) and I did not trust the supplier to “fix” it to my satisfaction. So in the end I decided to go for a fourth option, fix it myself. These are pretty big castings so machining them was going to be a challenge. As it happens I have a fairly large shaper machine that I bought on a whim about fifteen years ago and have never really found a use for - today was going to be its day! After much fiddling about with a clock gauge and needing two pairs of hands rather than just one, the base was finally accurately mounted onto the shaper box and machining proceeded straightforwardly. Next the column was mounted on the milling machine with a similar amount of faffing around and again machining proceeded with no problems. However, on reassembling, the column and base were still not square, not by the huge amounts before but still too much. Now I really had to scratch my head - I had been so careful in setting up, I could not believe I had got it wrong. Eventually the penny dropped. When I had mounted the base onto the shaper I had located the top (ground) face of the casting against the table. I had assumed that its face was parallel with the bed faces, no such luck. On checking these faces were definitely not parallel. I now had to remount the base but located on parallels (see below). (This was a job I needed three pairs of hands for!)

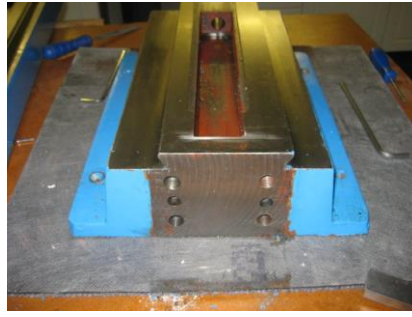
The poor finish

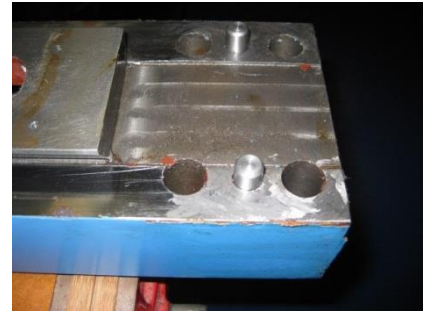
The bodge on the end of the column

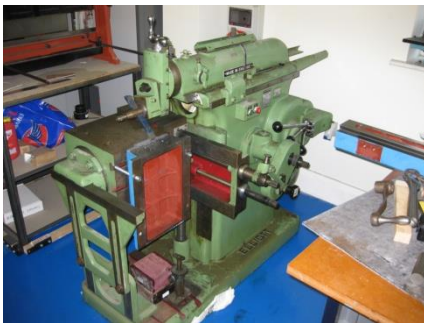
The base mounted on the shaper

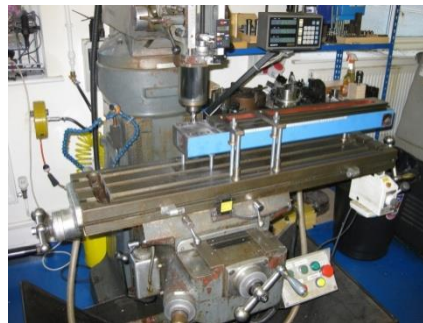
The column mounted on the mill

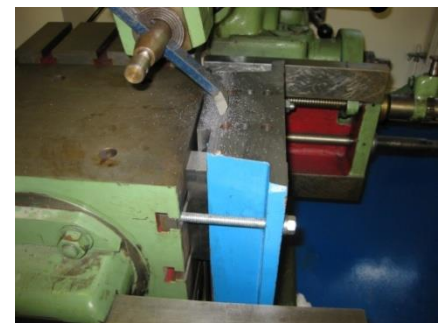
Machining the base for the second time!

Having re-machined the base again and re-assembled - success. Now I could not get a feeler gauge between any part of the blade and the column. I have since acquired a larger square and still cannot detect any gap. My only problem now is that the holes for the two taper dowels locating the column are stepped, and so are of no use. I am not sure if they really add to the stability of the column, or if they are just there for ease of assembly. I am now undecided as to whether to leave the dowels out, or to try and make new pins and a reamer and re-machine them. Perhaps more knowledgeable members might have a view on this?

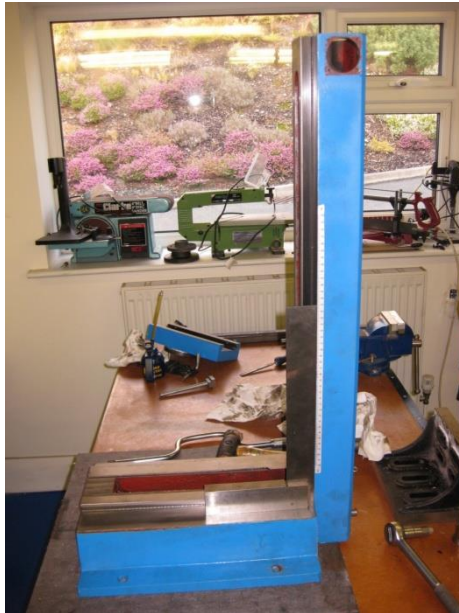
The column now accurately located
