## *Petrol Perils – Mike Brown*

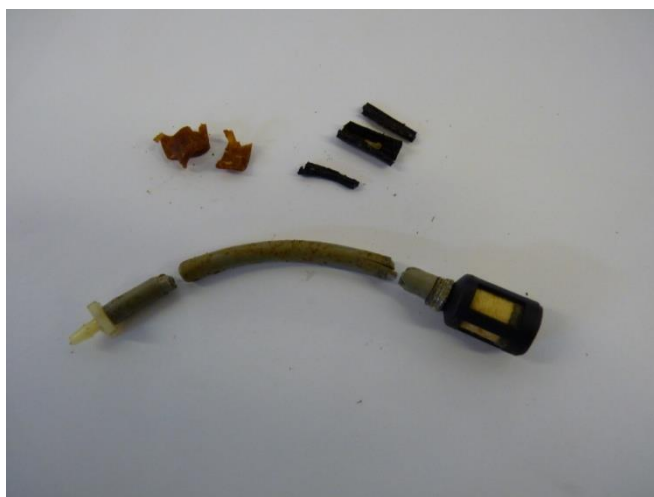
Back in the workshop the problem soon became apparent. Where the petrol pipe entered the plastic tank, there was a junction, a second short piece of flexible pipe dangled in the tank with a petrol filter on the end of it. The idea being that whatever the orientation of the trimmer, the filter would always be at the bottom. Unfortunately the flexible section of pipe was now rigid, crumbly, and broken into sections. Some other bits of mangled plastic also emerged from the tank.

*Parts found in the trimmer petrol tank.*

Now if you have managed to keep awake so far, then congratulations and let's go back to the original problem. It appears that my fuel pipe had survived for over 10 years until exposed to the ethanol that rotted it in just two weeks (I still don't know what the other rotted plastic parts in the tank were, I hope that they were not vital! Fortunately a trip to the Midlands Exhibition provided the solution. There was a stand there selling, amongst other things, clear silicone rubber tubing of small diameter. I asked the vendor if it was suitable for petrol and his answer was very telling. He said he did not know, but he sold most of it to people with broken trimmers!
